Hot Corrosion of Single-Crystal NiAl-X Alloys

James A. Nesbitt
Lewis Research Center, Cleveland, Ohio

National Aeronautics and
Space Administration

May 1998

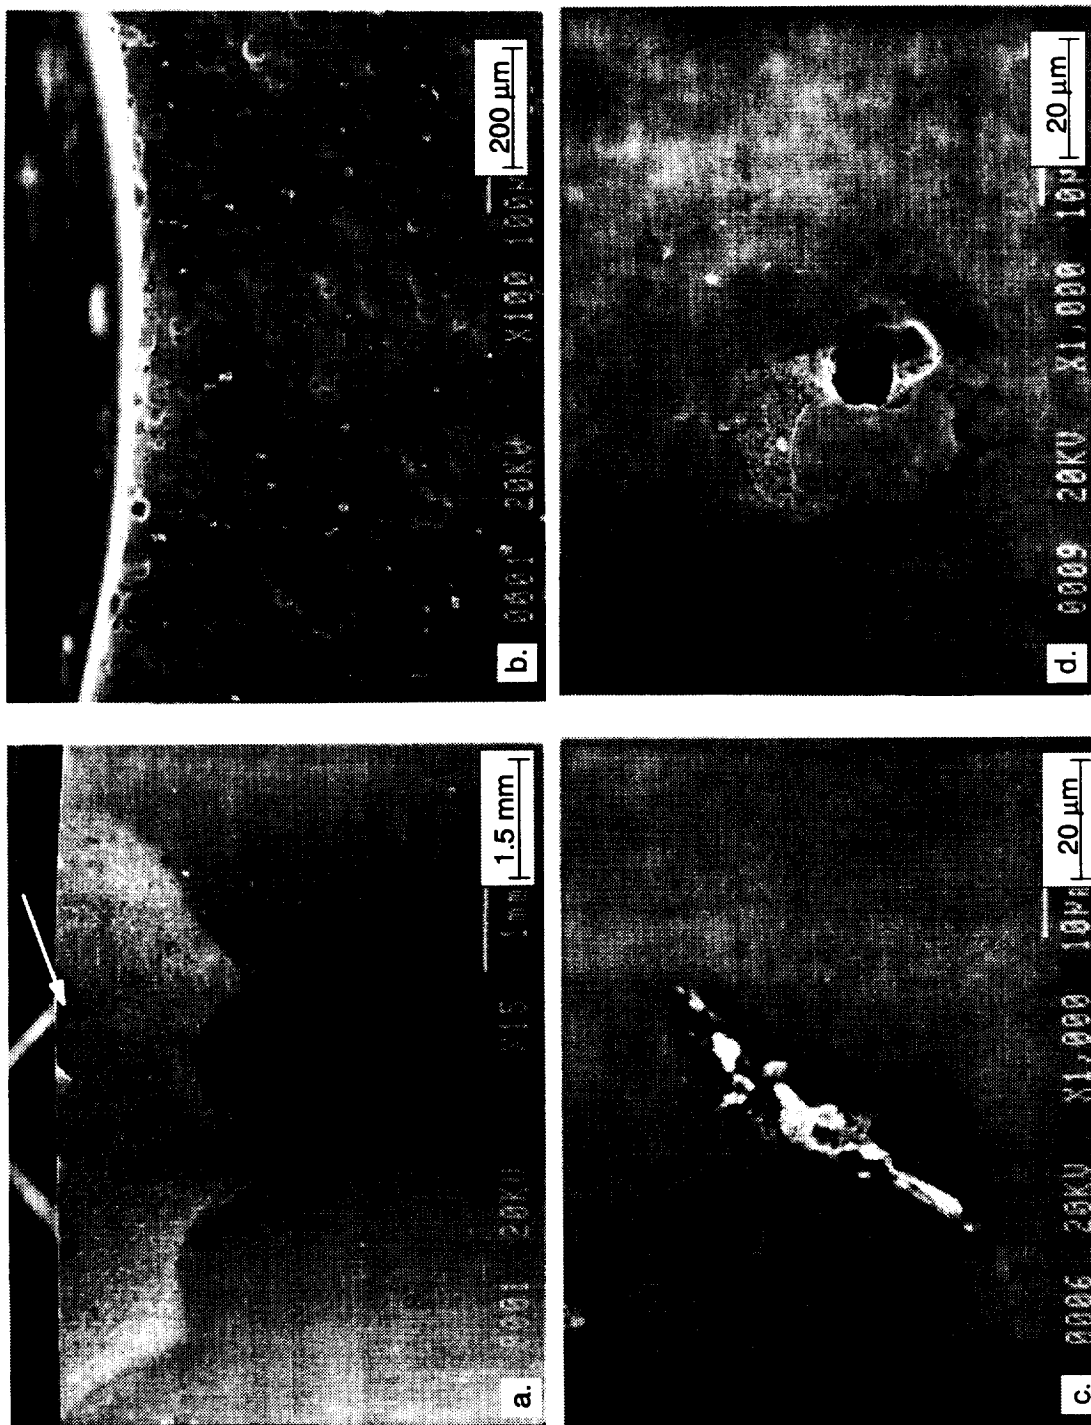
of the samples, often with a small "tarnished" region on the curved surface near where the electrode clip was attached. EDS analysis of the thin tarnished region detected Cl in addition to the matrix elements. However, after 10 hrs of testing, the tarnished region was not observed and did not appear to have any effect on the corrosion on the sample surface. Occasionally the electropolishing treatment left small regions on the surface of the sample with a different morphology (Fig 3a). A closer view of one of these areas showed that it contained numerous etch pits (Fig 3b). (Several of the pits shown in this figure contain epoxy from previously mounting and polishing one end of this sample.) On the remainder of the surface, pits were occasionally observed, but much less frequently than in this region, and they tended to have more rounded edges as though they were being dissolved. Sufficient material was removed from the surface to occasionally reveal oxide and carbide particles (Fig 3c). The electropolish did not seem to preferentially attack the multiphase regions consisting of primarily Heusler, β NiAl and Ni(Hf,Ti)Si, as shown in Fig 3d. As previously mentioned, porosity, such as that shown in Fig 3d, was commonly associated with these multiphase regions.^{6,18} The smooth surface typical of the electropolishing treatment is also apparent in Fig 3c,d.

Fig. 3 SEM photos of AFN 26 after electropolishing (a) unusual region near one end, (b) etch pits in region indicated by arrow in (a) (many pores contain epoxy from previous mounting), (c) exposed Hf oxide particle, (d) multiphase Heulser, β -NiAl and Ni(Hf,Ti)Si particle with pore.

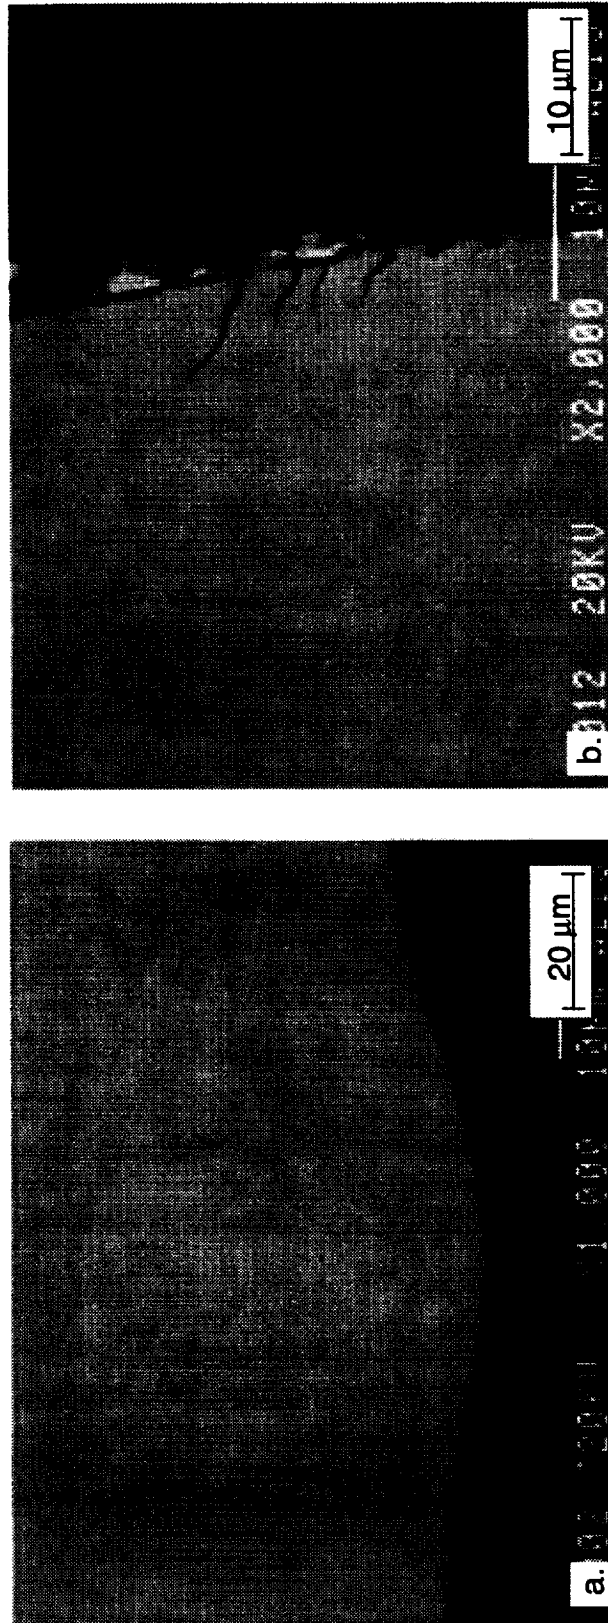
Due to the limited number of samples, only one sample (AFN26) was mounted and polished in order to examine the surface in cross section after electropolishing. Although most regions appeared smooth (Fig 4a), many regions still contained small cracks penetrating less than 10 microns into the sample (Fig 4b). However, some cracks were observed which extended hundreds of microns into the sample (Fig 5) while some cracks appeared widened and tips blunted by the electropolishing treatment (Fig 6). Following all surface treatments, the samples were ultrasonically cleaned with acetone and ethanol prior to testing. During the first series of burner rig testing (Series I), all of the electropolished samples underwent some form of fracture before 150 cycles. Upon examination, it was apparent that there was considerably greater attack and corrosion product formation on the ID surface of the samples than on the OD surface. This accelerated attack was likely the result of incomplete removal of the EDM recast layer and the remaining cracks. The volume expansion associated with the significant corrosion product formation on the ID was presumably the cause for the fracture of the samples. In summary, electropolishing generally resulted in a shiny, relatively smooth metallic finish although some distinct regions showed significant pit formation. Fine cracks were not all removed by electropolishing and although some cracks were widened and the tips blunted, many deep cracks remained after the electropolishing treatment.

Fig. 4 SEM photos of polished cross section of AFN26 showing (a) typical smooth surface (ID surface shown) and (b) typical fine cracks from EDM cutting (OD edge shown).

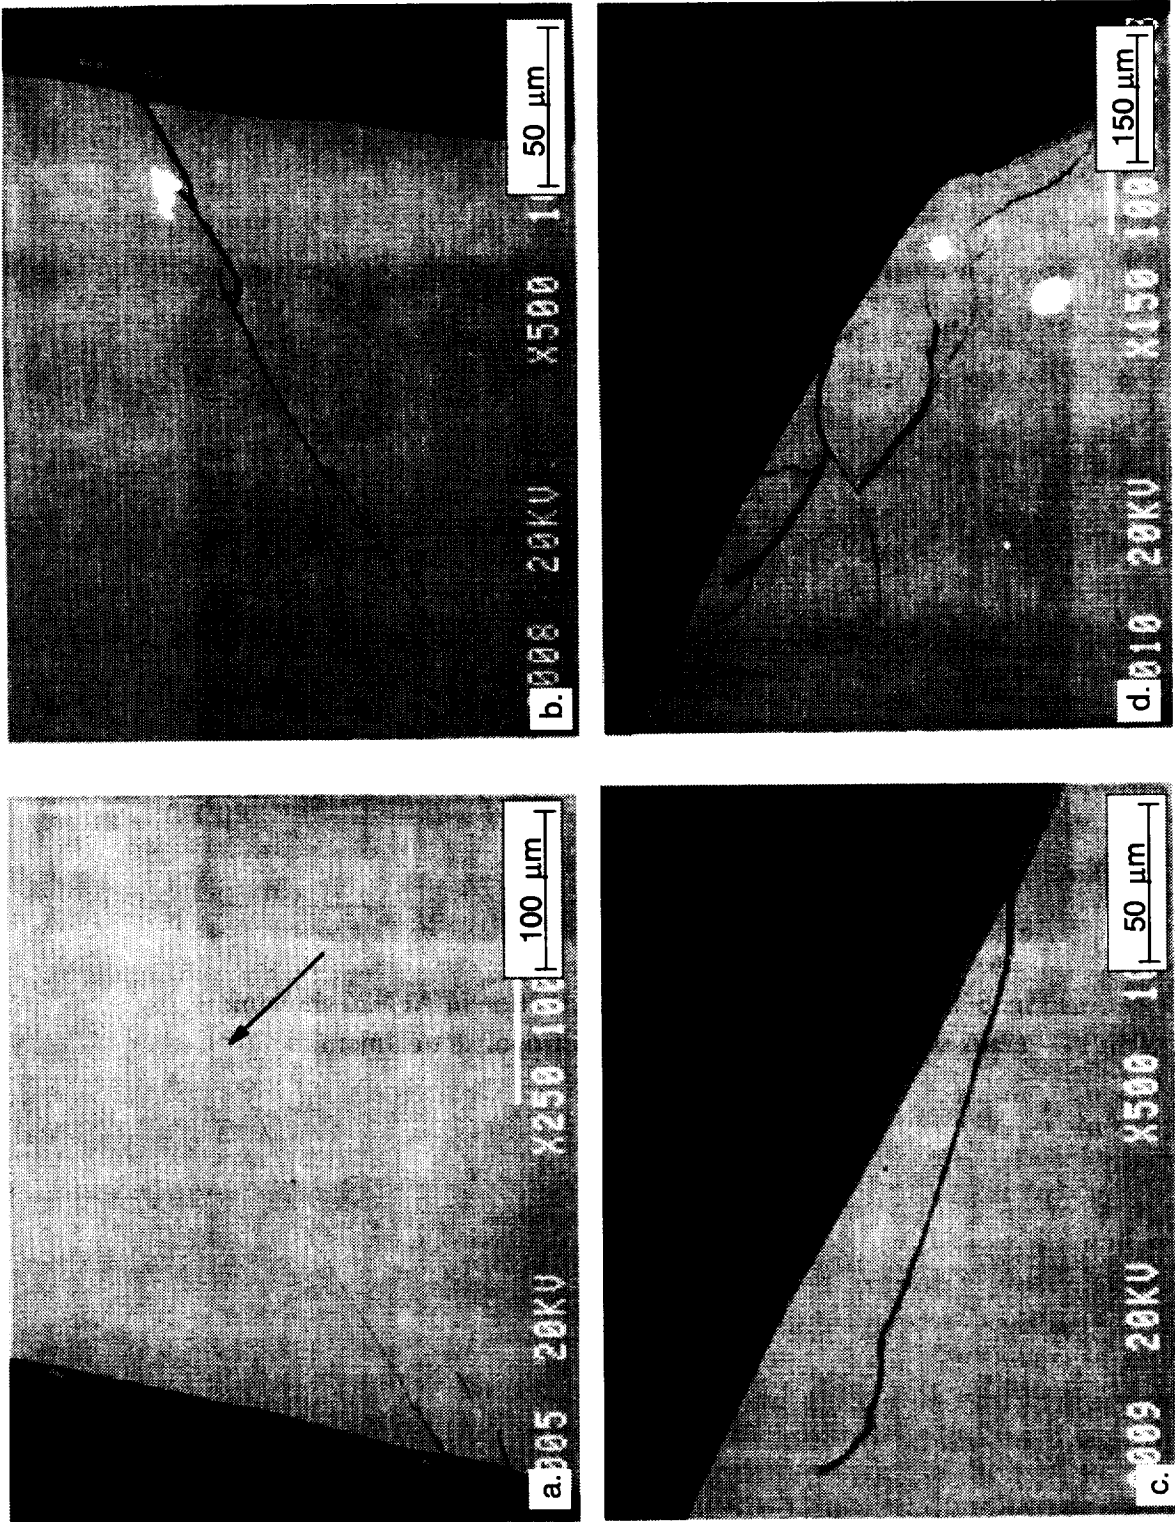
Fig. 5 SEM photos of AFN26 showing cracks from EDM cutting (a),(b) at the ID edge, and (c),(d) at the OD edge. Arrow shows depth of penetration in (a). (Bright particles in (b) and (d) are Hf-rich Heusler and/or NiHfSi particles.

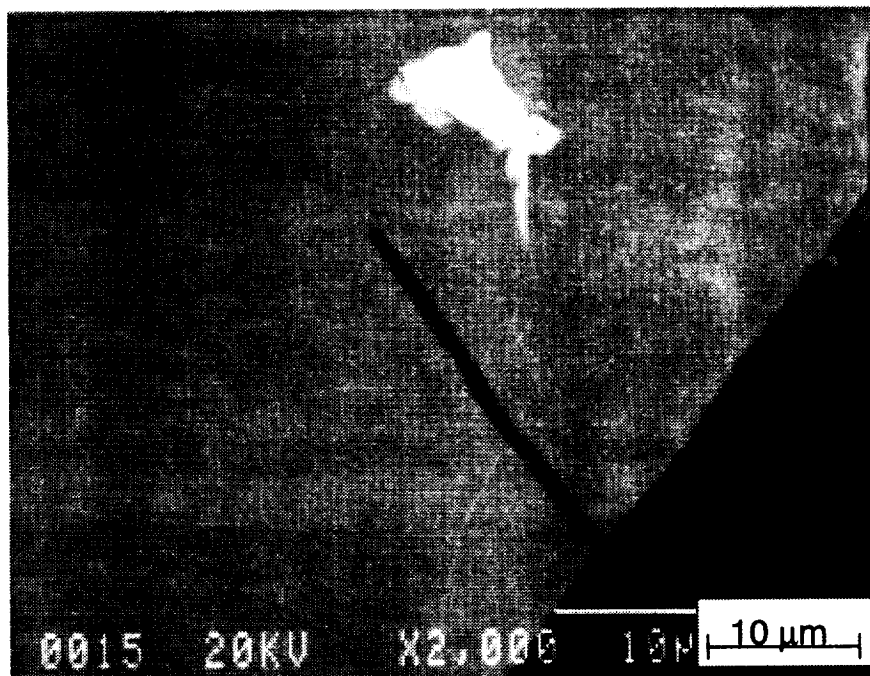
Fig. 6 SEM photos of polished cross section of AFN26 showing crack which appears blunted by electropolish treatment.

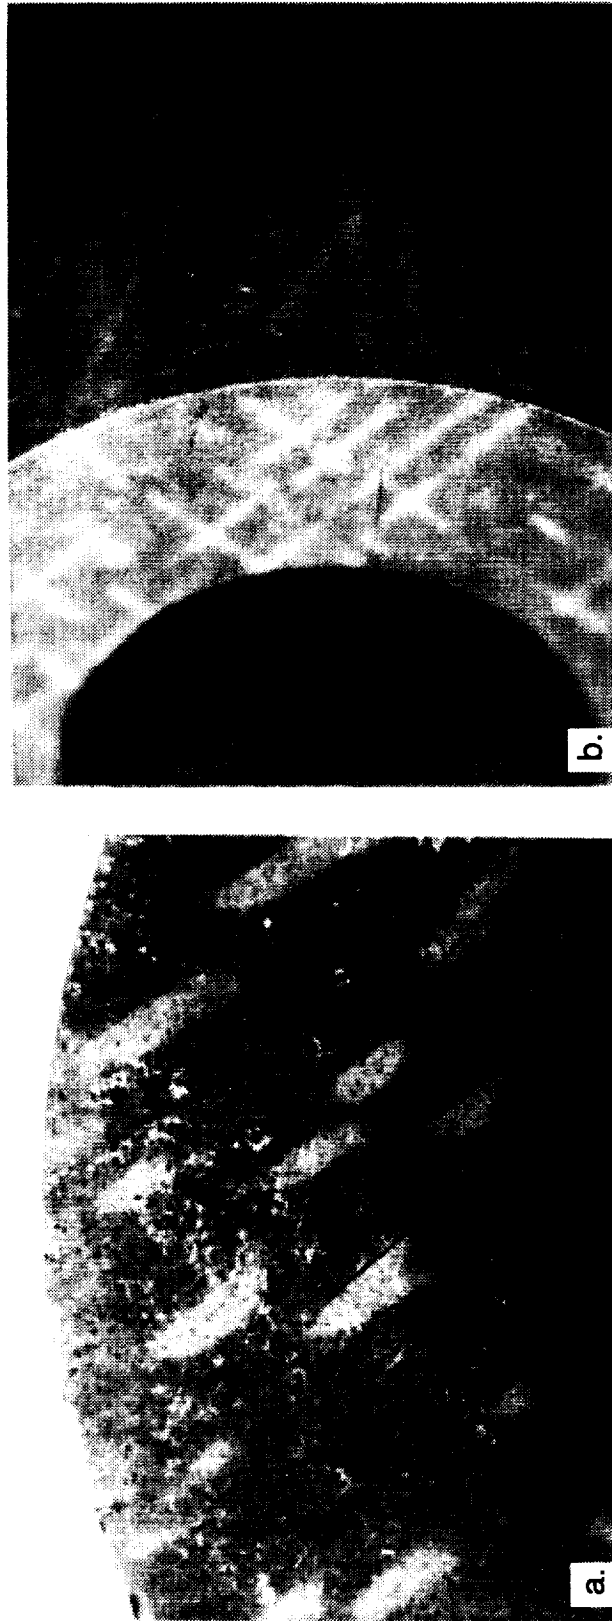
milled only (AFN20 and D219) and those which were electropolished prior to chemical milling (AFN19 and AFN21-26). Cracks at the edges, widened either by the electropolish or chemical milling treatments, were found on almost all samples and were more prevalent on the ID (Fig 9a) than on the OD (Fig 9b).

Fig. 9 Macrophotos of samples after electropolish and chemical milling showing cracks (a) at ID edge in AFN19, and (b) at OD edge of AFN20.

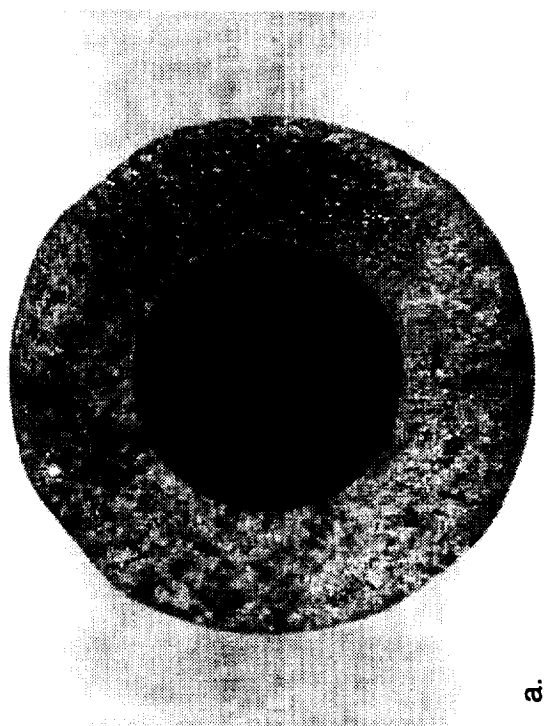
As previously mentioned, the two ends of the AFN24 sample were significantly different after electropolishing and chemical milling (Fig 10a,b). One surface appeared rough and shiny while the other exhibited the flat matte finish. Not surprisingly, the two ends responded very differently during hot corrosion testing with the originally rough but shiny end undergoing accelerated attack. Optical macrographs of the ends and curved surface are shown in Fig 50. Magnified SEM views of the rough end are shown in Fig 51. EDS spectra for the small bumpy nodules in Fig 51c are similar to those previously shown for scales with a similar morphology (see Figs 43 and 41b). The composition of the darker scale atop the mounds was also similar to that measured on the mounds in AFN19 (Figs 40c and 41c).

Fig. 10 Macrophotos of AFN24 after electropolishing and chemical milling, (a) shiny but rough, metallic surface (b), (c) dark, flat matte surface typical on high-Ti containing samples.

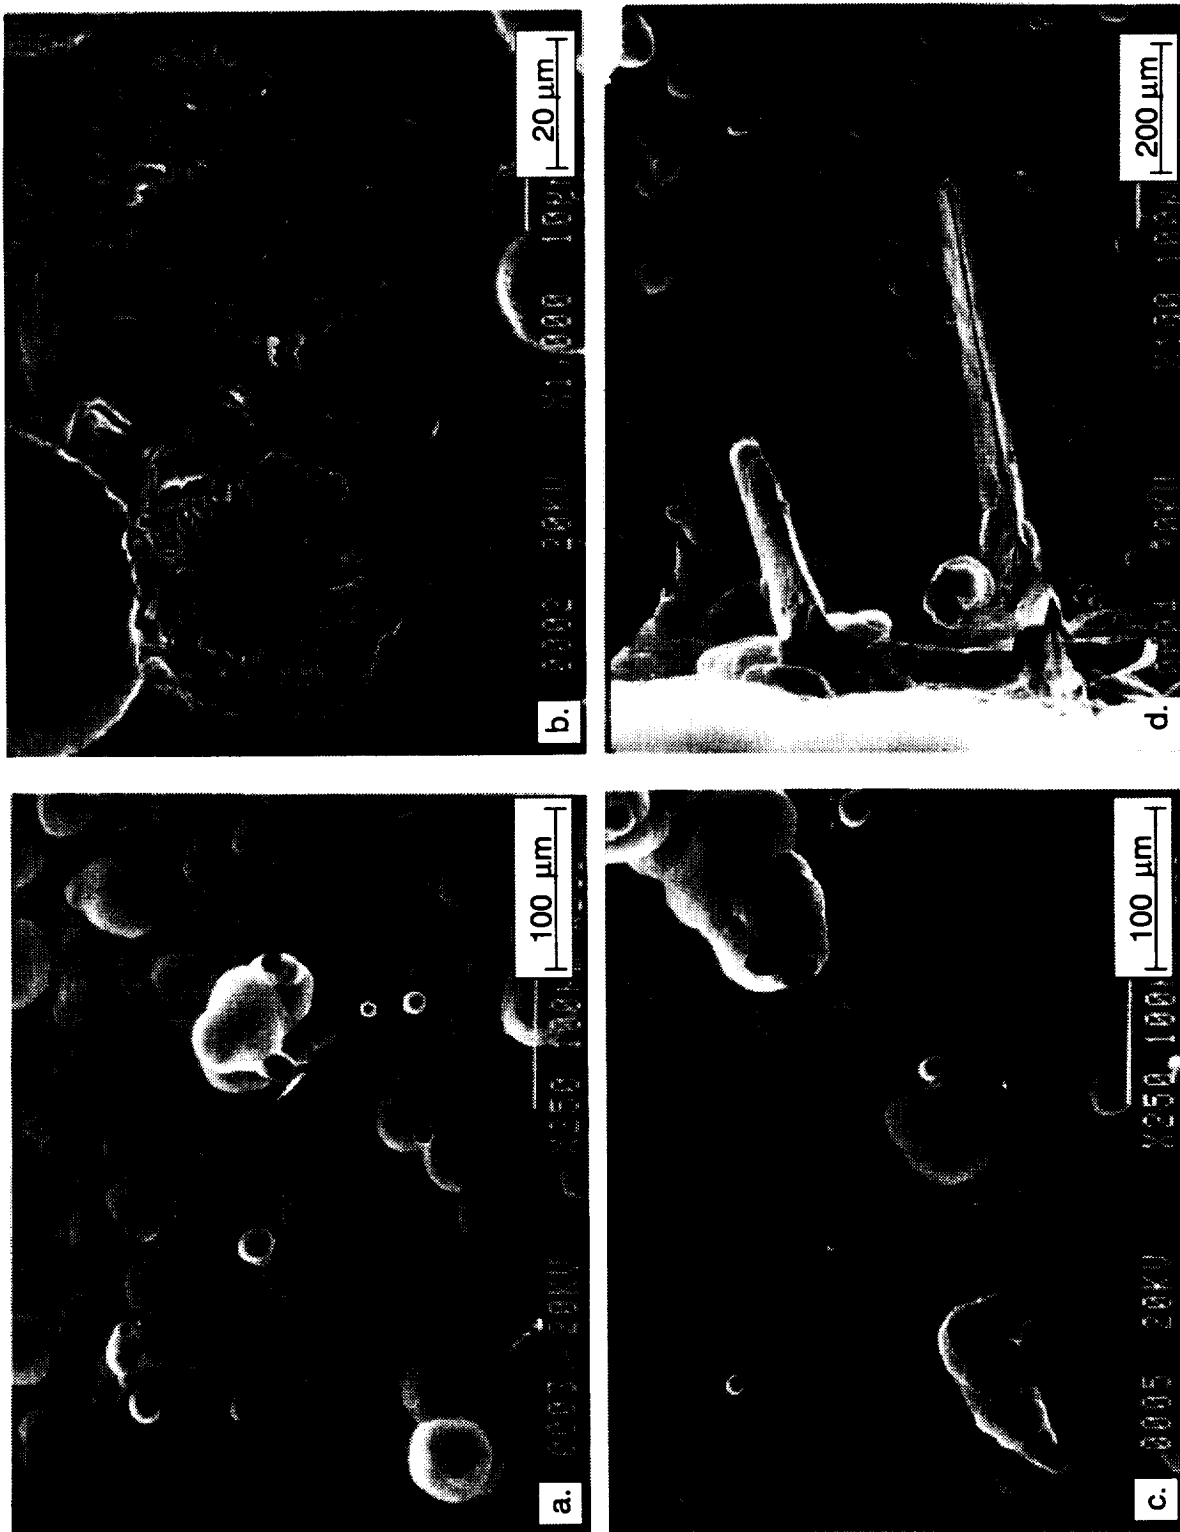
Microstructural Features. At an intermediate magnification, the surface of D218, which had only received the chemical milling treatment, appeared polycrystalline (Fig 12a). However, at higher magnifications, large, shallow, oval-shaped etch pits were apparent (Fig 12b) as well as surface-connected porosity (Fig 12c). This morphology was typical on the curved surfaces, flat ends, as well as what could be seen on the ID surface. Cracks near the edges appeared widened and crack tips blunted (Fig 12d). The chemical milling treatment also revealed small HfO_2 particles highlighting subgrain boundaries (Fig 13a,b), oxide/carbide particles at the surface (Fig 13c), as well as other unidentified microstructural features (Fig 14).

Fig. 12 SEM photos of the surface of D218 after chemical milling (a,b) general surface features, (c) porosity, and (d) blunted cracks.

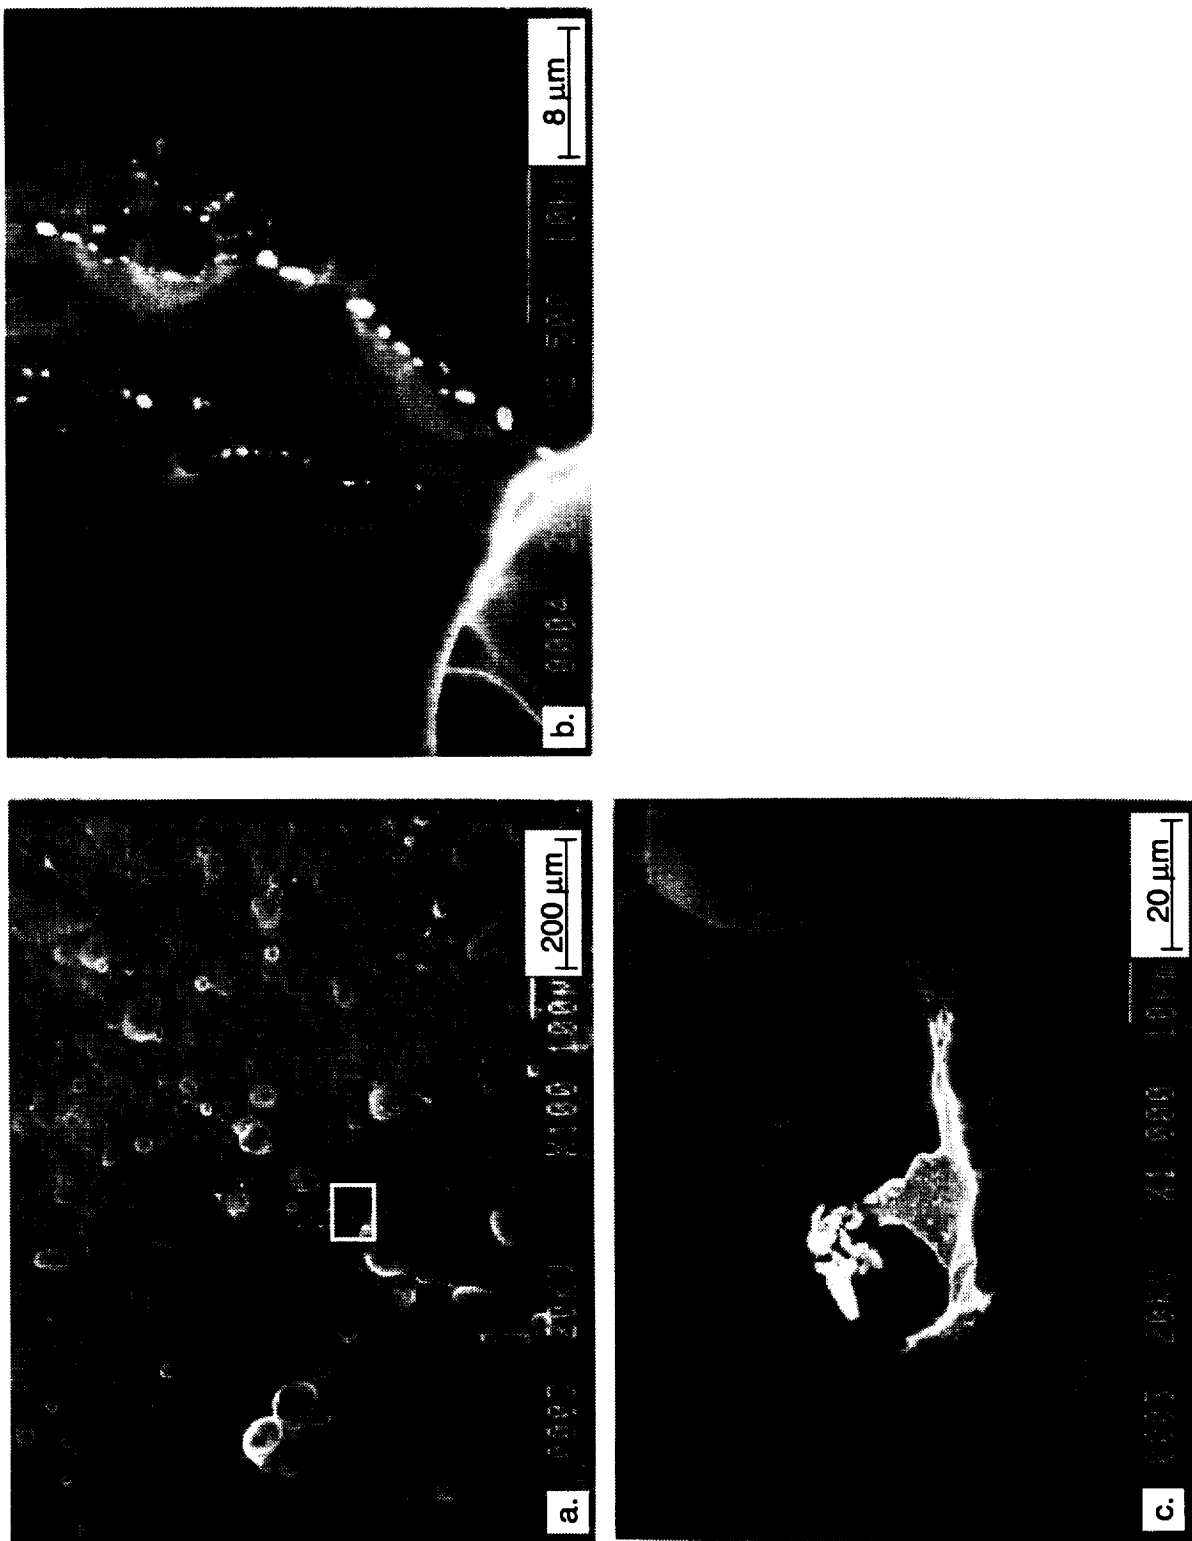
Fig. 13 SEM photos of the surface of D218 after chemical milling (a) general surface features, (b) high magnification of inset in (a) showing HfO₂ particles, (c) oxide/carbide particles.

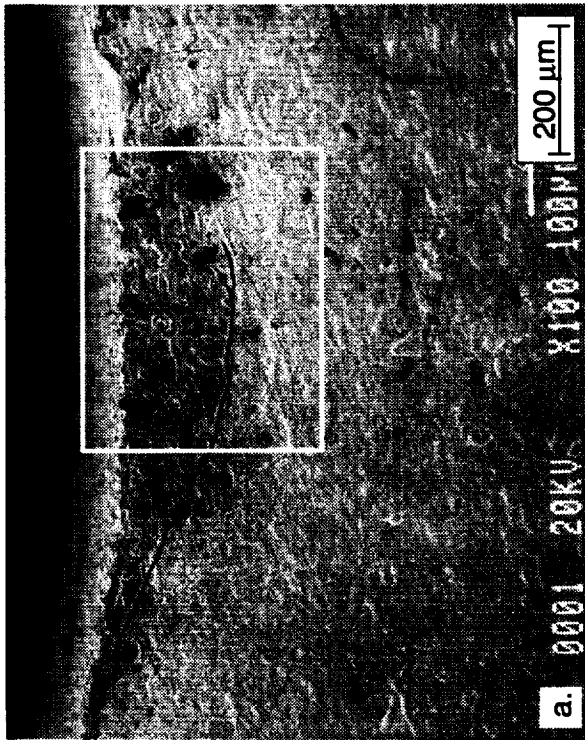
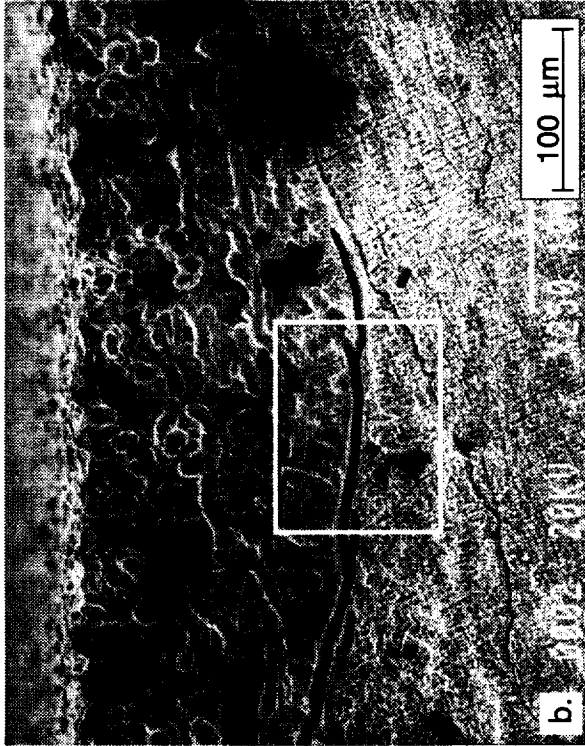
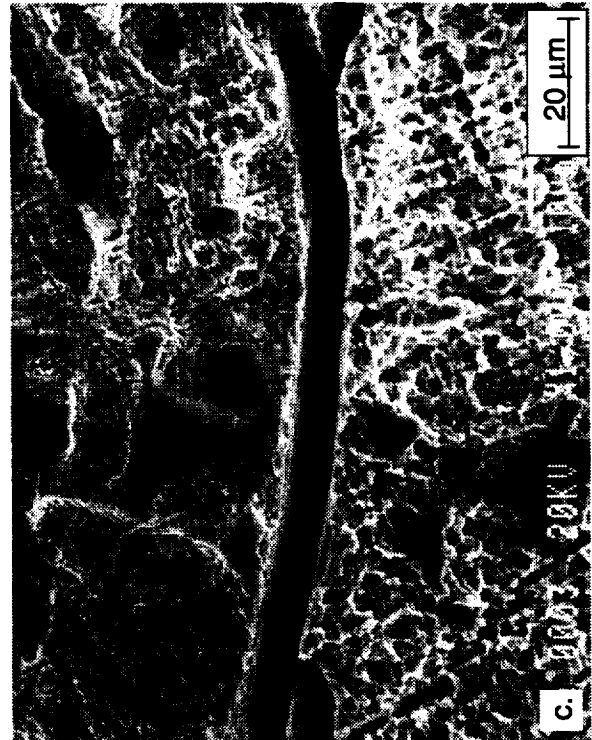
different sides of a crack or deeply etched subgrain boundary in AFN20 is evident in Fig 19. In addition to pits and crevices produced by the chemical milling, pre-existing porosity was also observed on the surface of samples as shown in Fig 20. The chemical milling treatment did appear to widen and blunt cracks at the edges of the samples, as shown in Fig 21. As with the electropolishing treatment, chemical milling revealed oxides and carbides at the surface (Fig 22).

Fig. 19 SEM micrographs of AFN20 after chemical milling showing different etching patterns on either side of a crack or etched subgrain boundary, (b,c) are higher magnifications of boxes shown in (a,b).

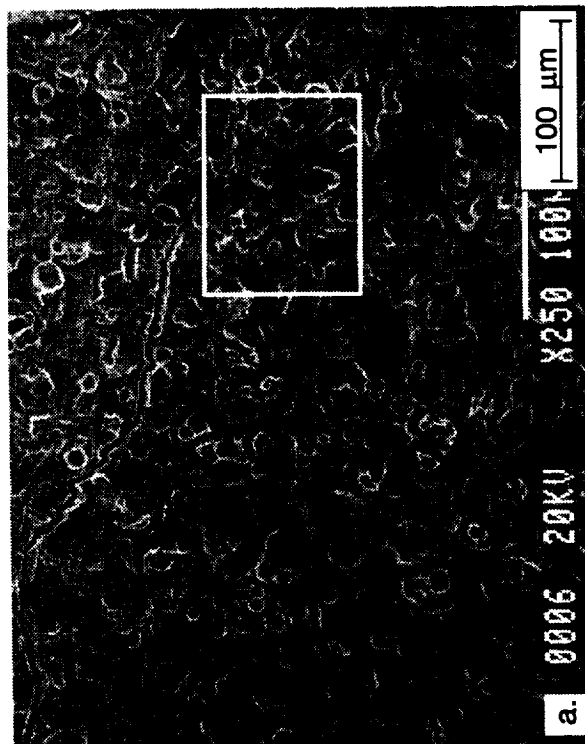
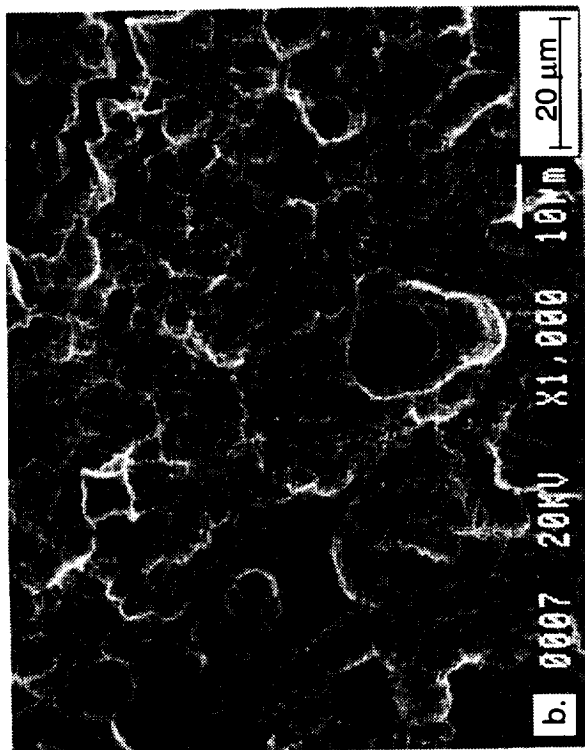
Fig. 20 SEM micrographs of D219 after chemical milling showing porosity, pits and attack at a subgrain boundary.

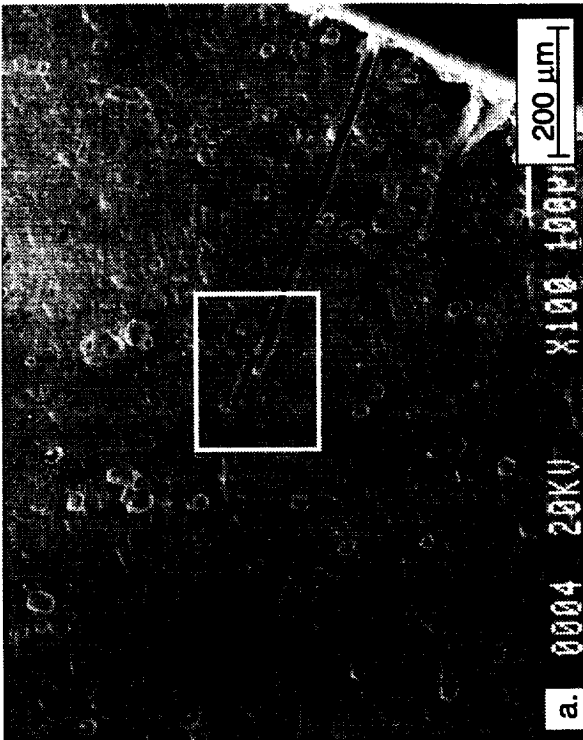
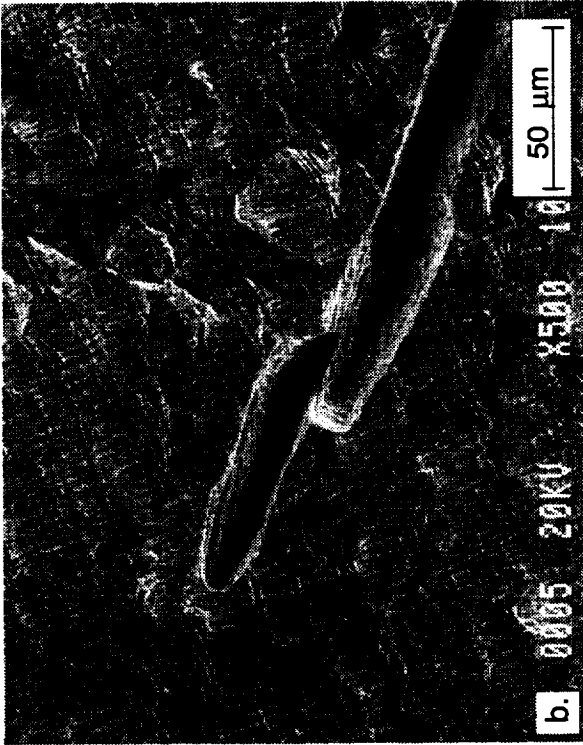
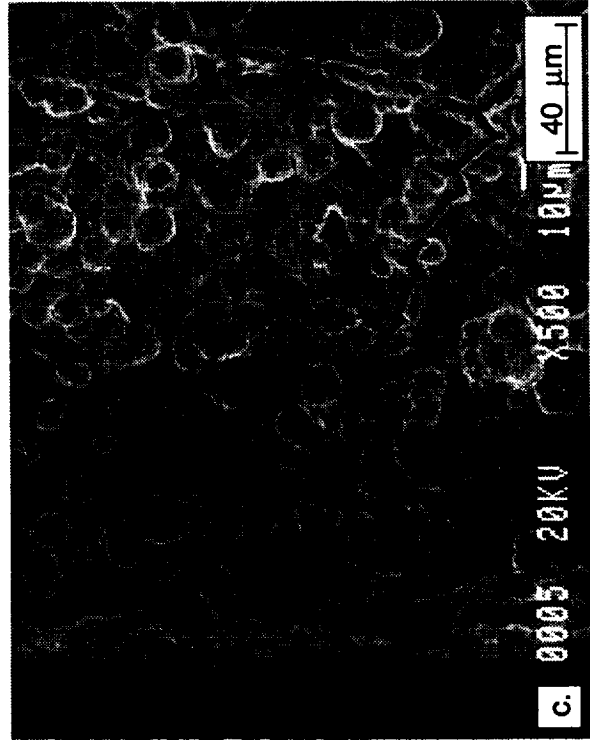
Fig. 21 SEM micrographs of cracks at the surface after chemical milling (a,b) AFN20, (c) D219.

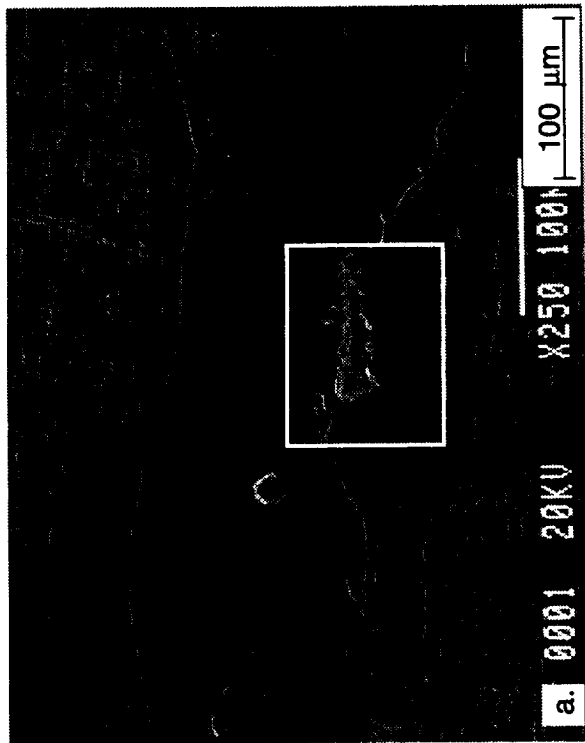
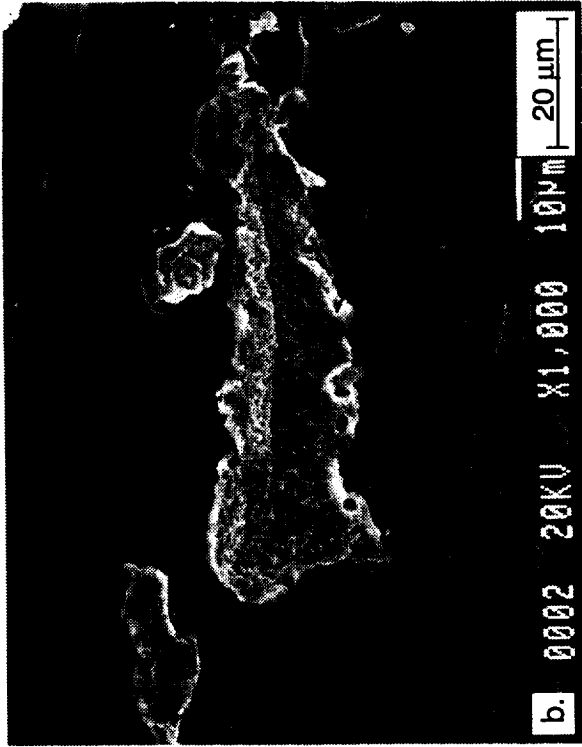
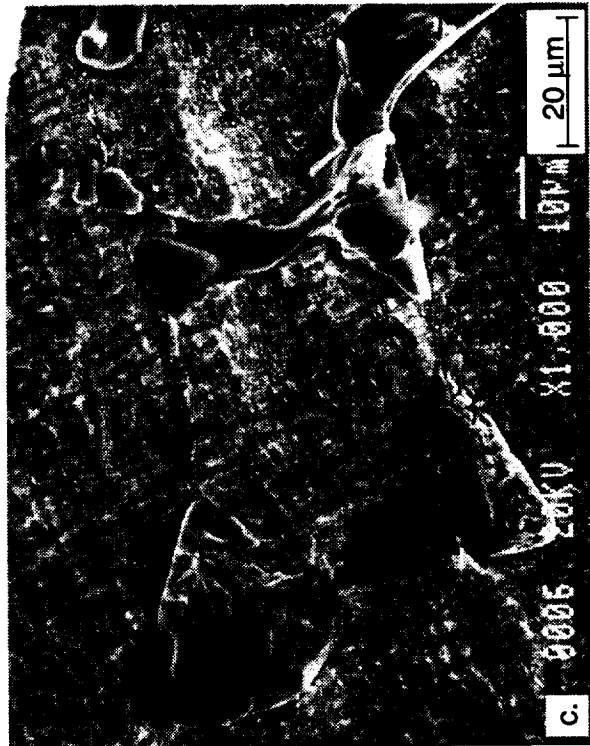
Fig. 22 SEM micrographs of oxides or carbides at the surface after chemical milling (a,b) D219, (c) AFN20.

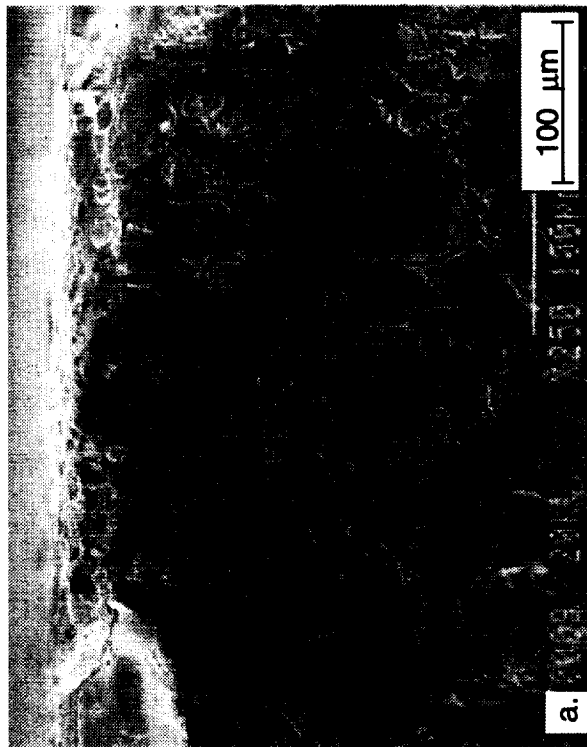
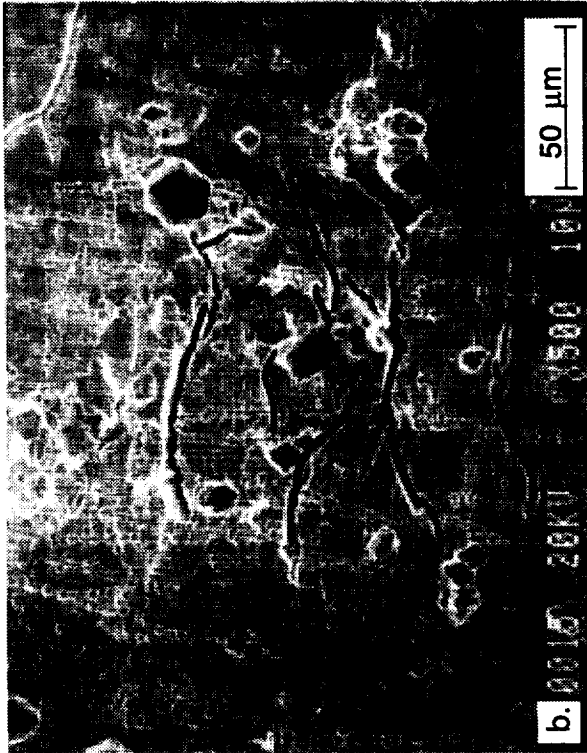
Fig. 27 SEM micrographs after electropolish and chemical milling showing cracks in the surface of AFN23 (a,b) at the ends, and (c) on the curved surface.

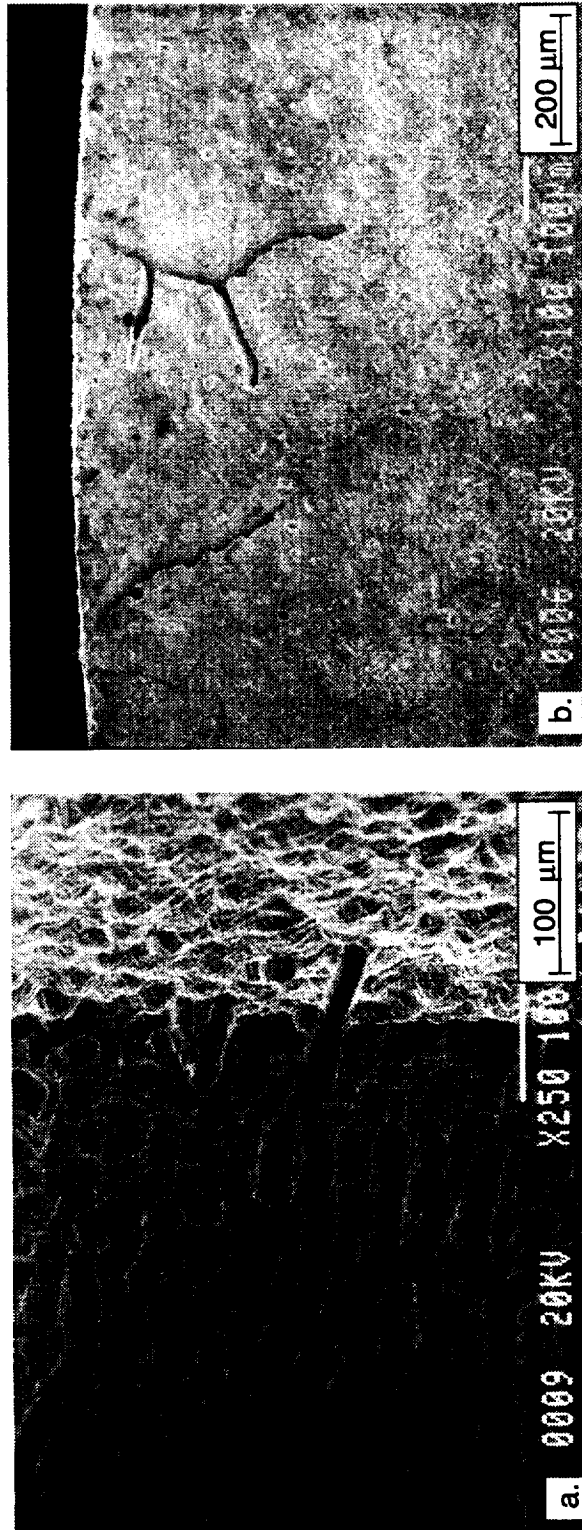
Fig. 28 SEM micrographs after electropolish and chemical milling of AFN26 showing etched cracks..

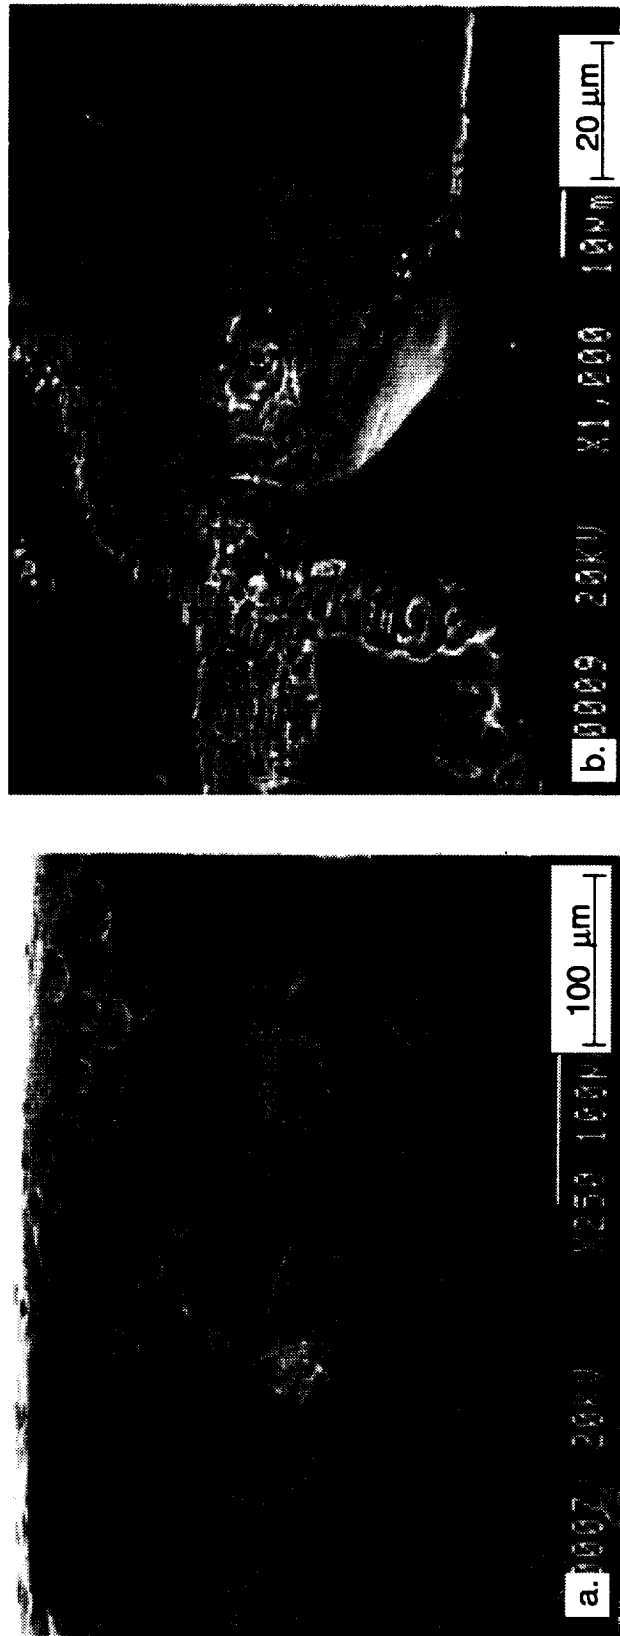
Fig. 29 SEM micrographs after electropolish and chemical milling of AFN23 showing unusual etch features on surface.

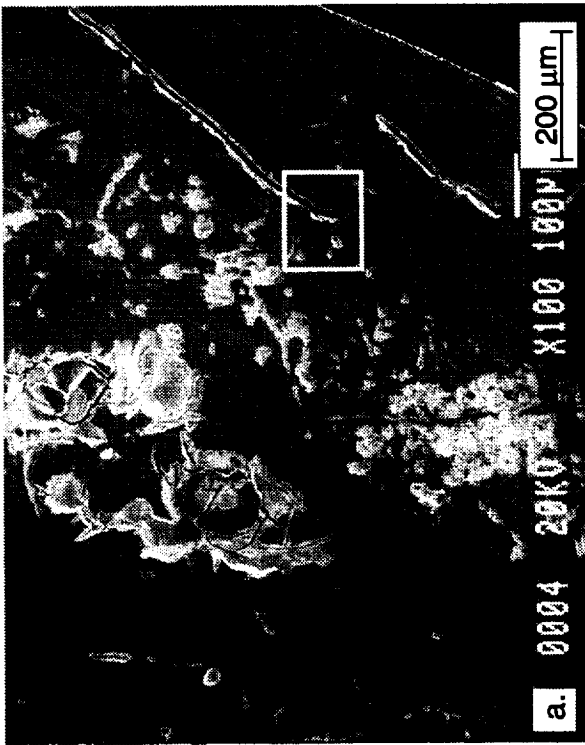
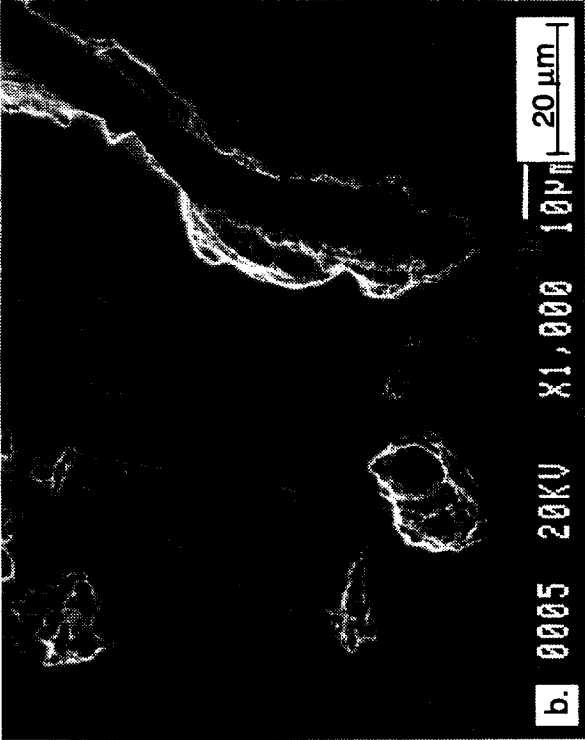
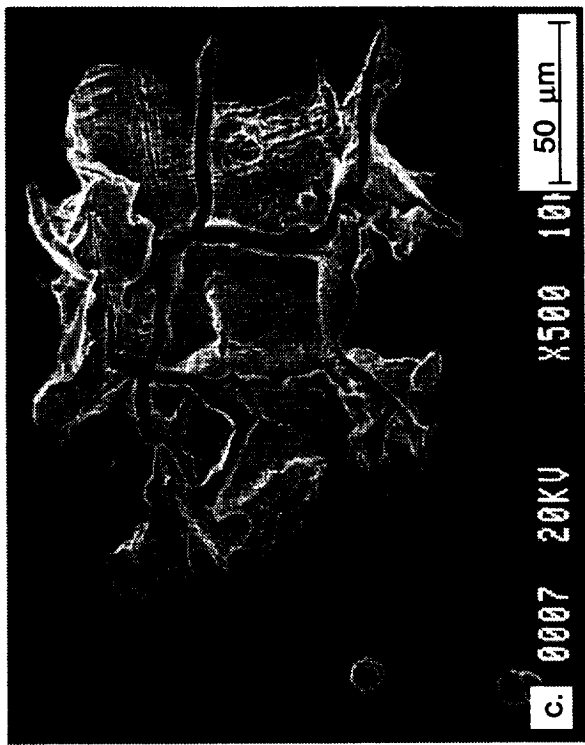
Fig. 34 SEM micrographs after mechanical polish showing large cracks on the surface of D219.

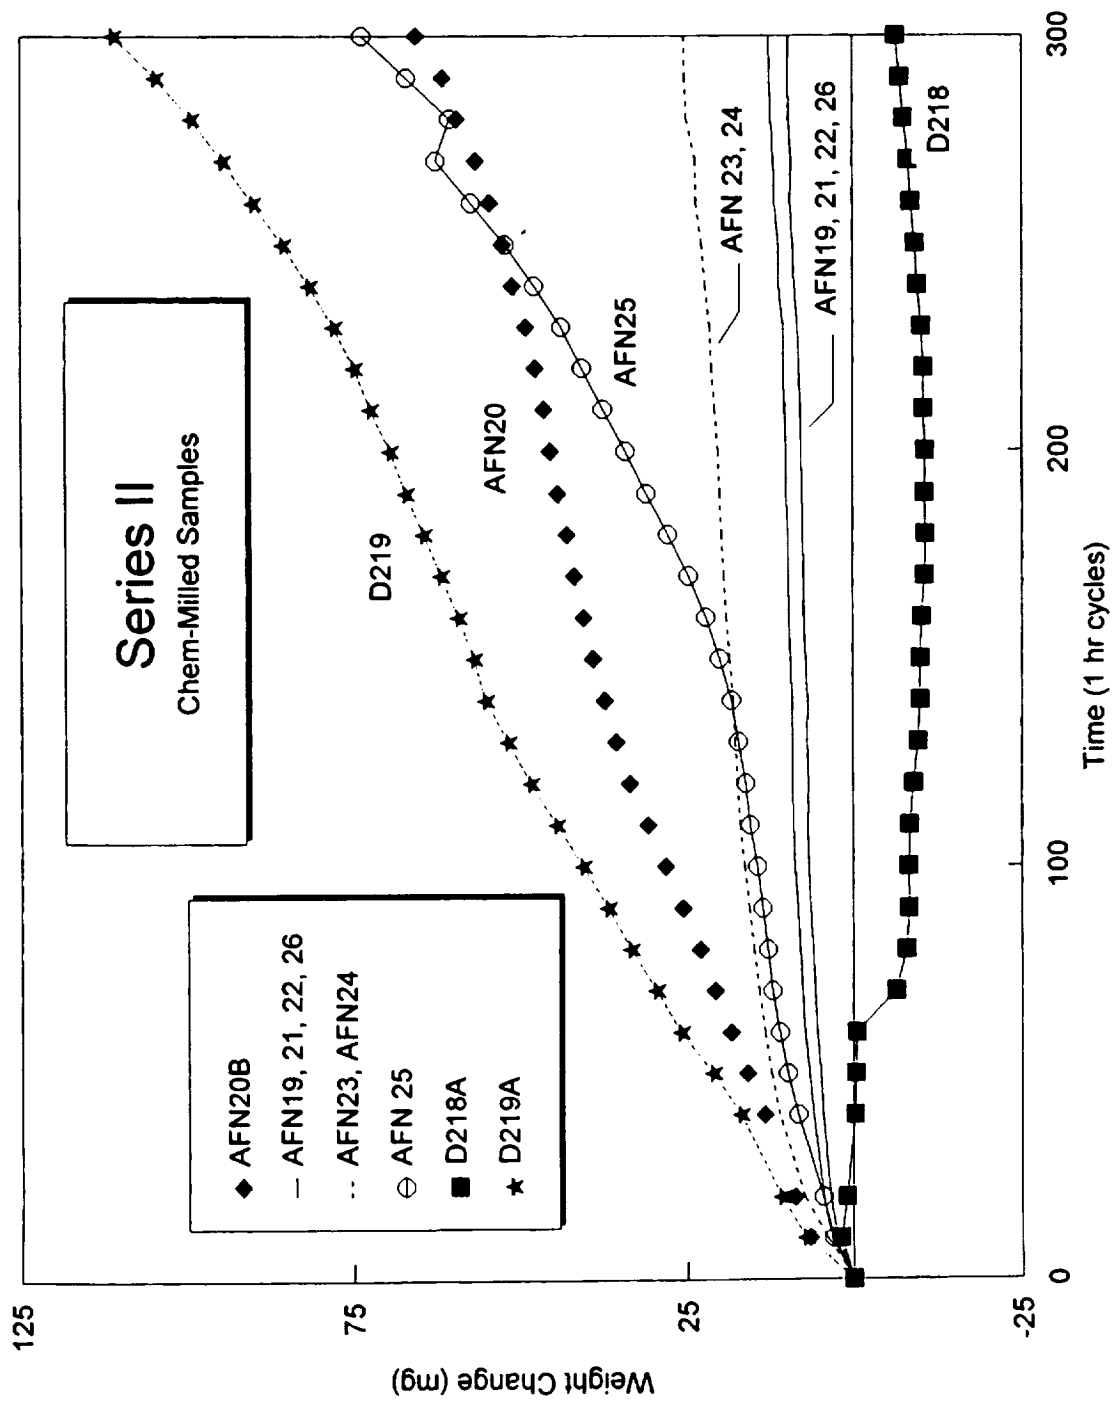
The weight change measured at various intervals through 300 hrs for Series II is shown in Fig 35. AFN20 and D219, alloys with 5% Ti but no Cr, exhibited the highest weight gains. Alloys with high Ti levels but containing 1-2% Cr (AFN19, AFN21-26) resulted in consistently lower weight gains. D218 with low Ti (1%) and no Cr also exhibited a small weight change representative of good hot corrosion behavior. The sharp weight loss between 60 and 70 hrs for this sample was due to the loss of a chip from the edge of the sample (shown below in Fig 54c). The rapid weight gain of AFN25 after 150 hrs appears as an exception to the alloys containing both high Ti and Cr. However, as will be shown and discussed below, this high weight gain was due to very significant localized attack on one region of the curved surface and is likely the result of a compositional inhomogeneity on this sample. Using the behavior of D218 as a baseline, the weight change data indicate that increasing the Ti from 1% to 5% (i.e., going from D218 to AFN20 or D219) increases the susceptibility of these alloys to hot corrosion attack. However, the addition of 1-2% Cr to the high-Ti alloys (i.e., AFN19, AFN21-26) reduces

the susceptibility of the alloys to hot corrosion attack. Stated otherwise, the addition of 1-2% Cr appears to negate the deleterious effect of the addition of 4-5%Ti on the hot corrosion resistance of these alloys.

Fig. 35 Weight change during burner rig testing for Series II.
